historic structure report  
architectural data section  
phase II: exterior preservation

JEFFERSON NATIONAL EXPANSION MEMORIAL  
OLD COURTHOUSE

NATIONAL HISTORIC SITE / MISSOURI

by  
David G. Henderson

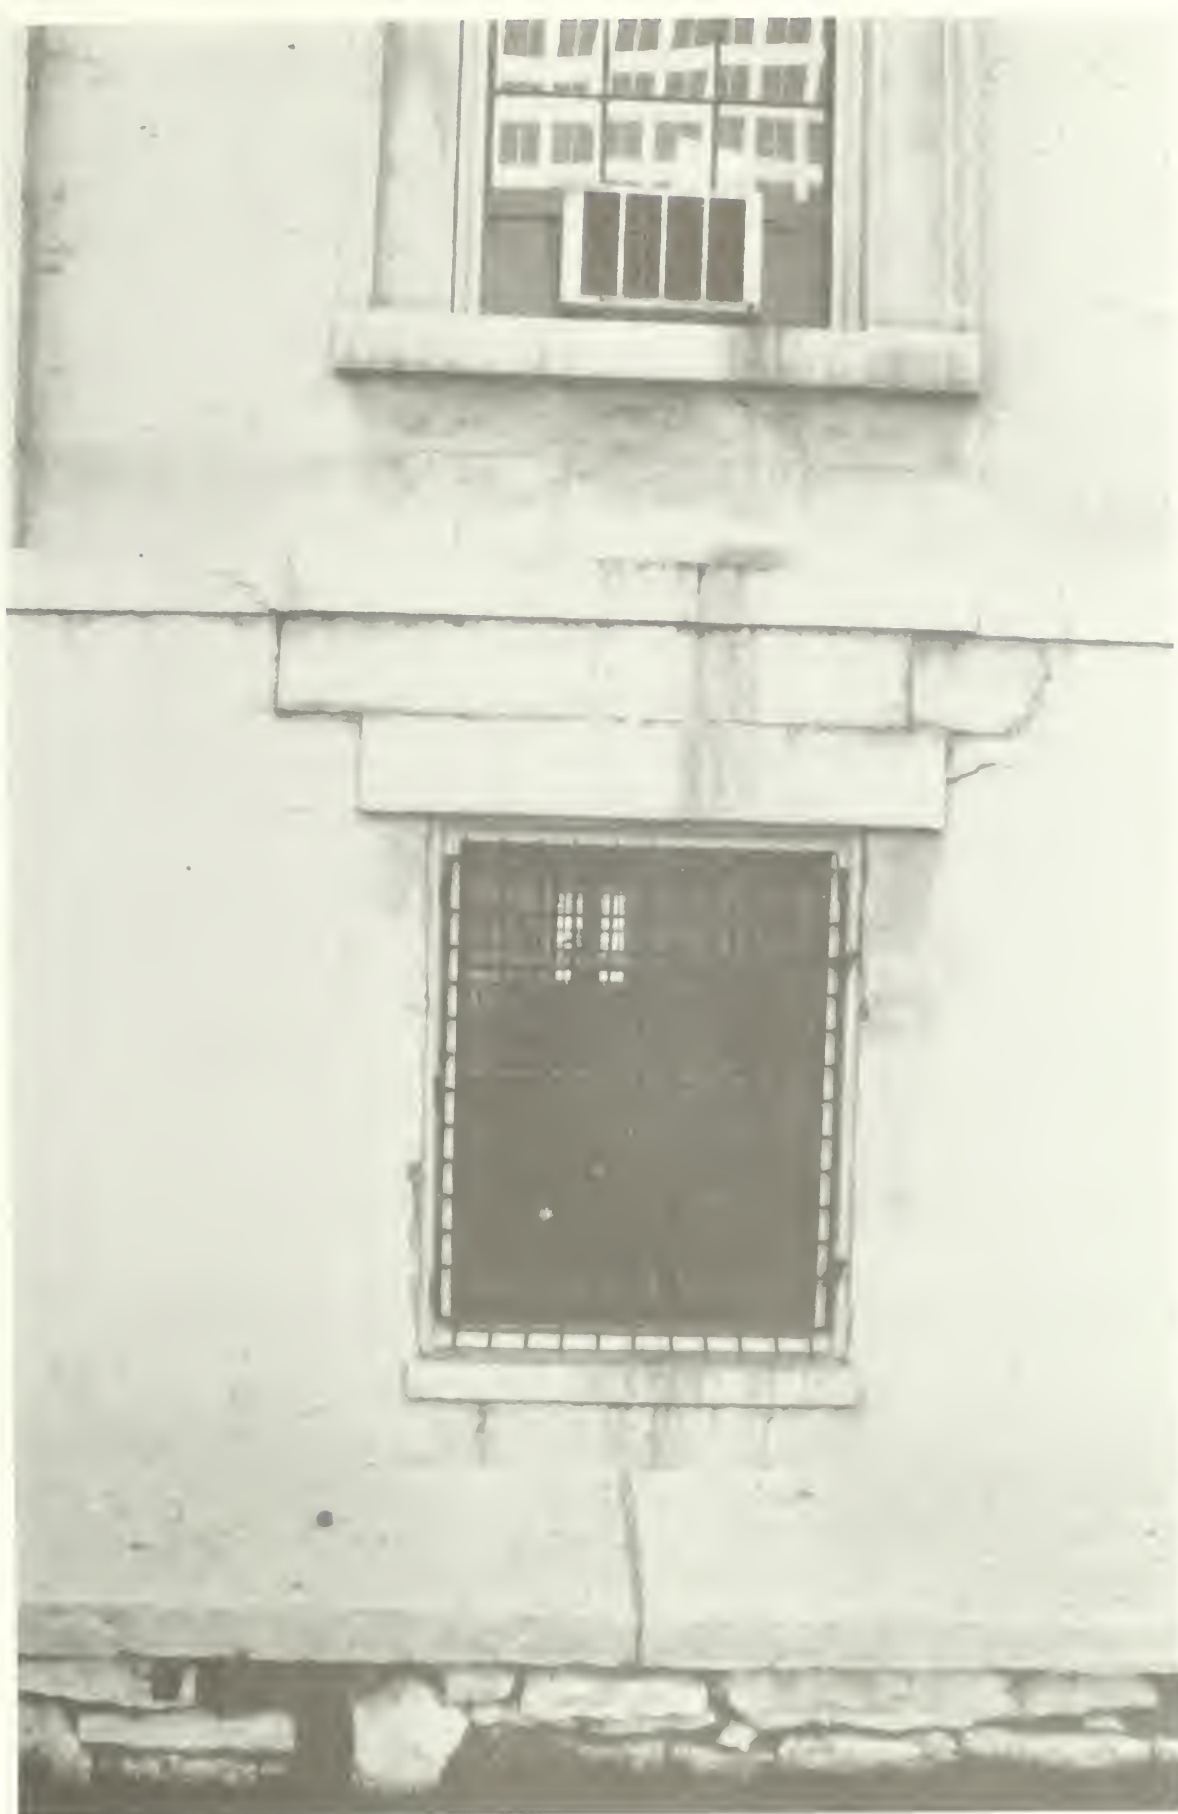
Kerlin also mentioned wall cracks over some of the windows, particularly the two basement windows in the north and south walls of the east wing near the portico. He believed these cracks were caused by rusting retaining bars for the iron grilles covering the windows.

32. Displaced stones at basement window, north side of east wing (south side similar).

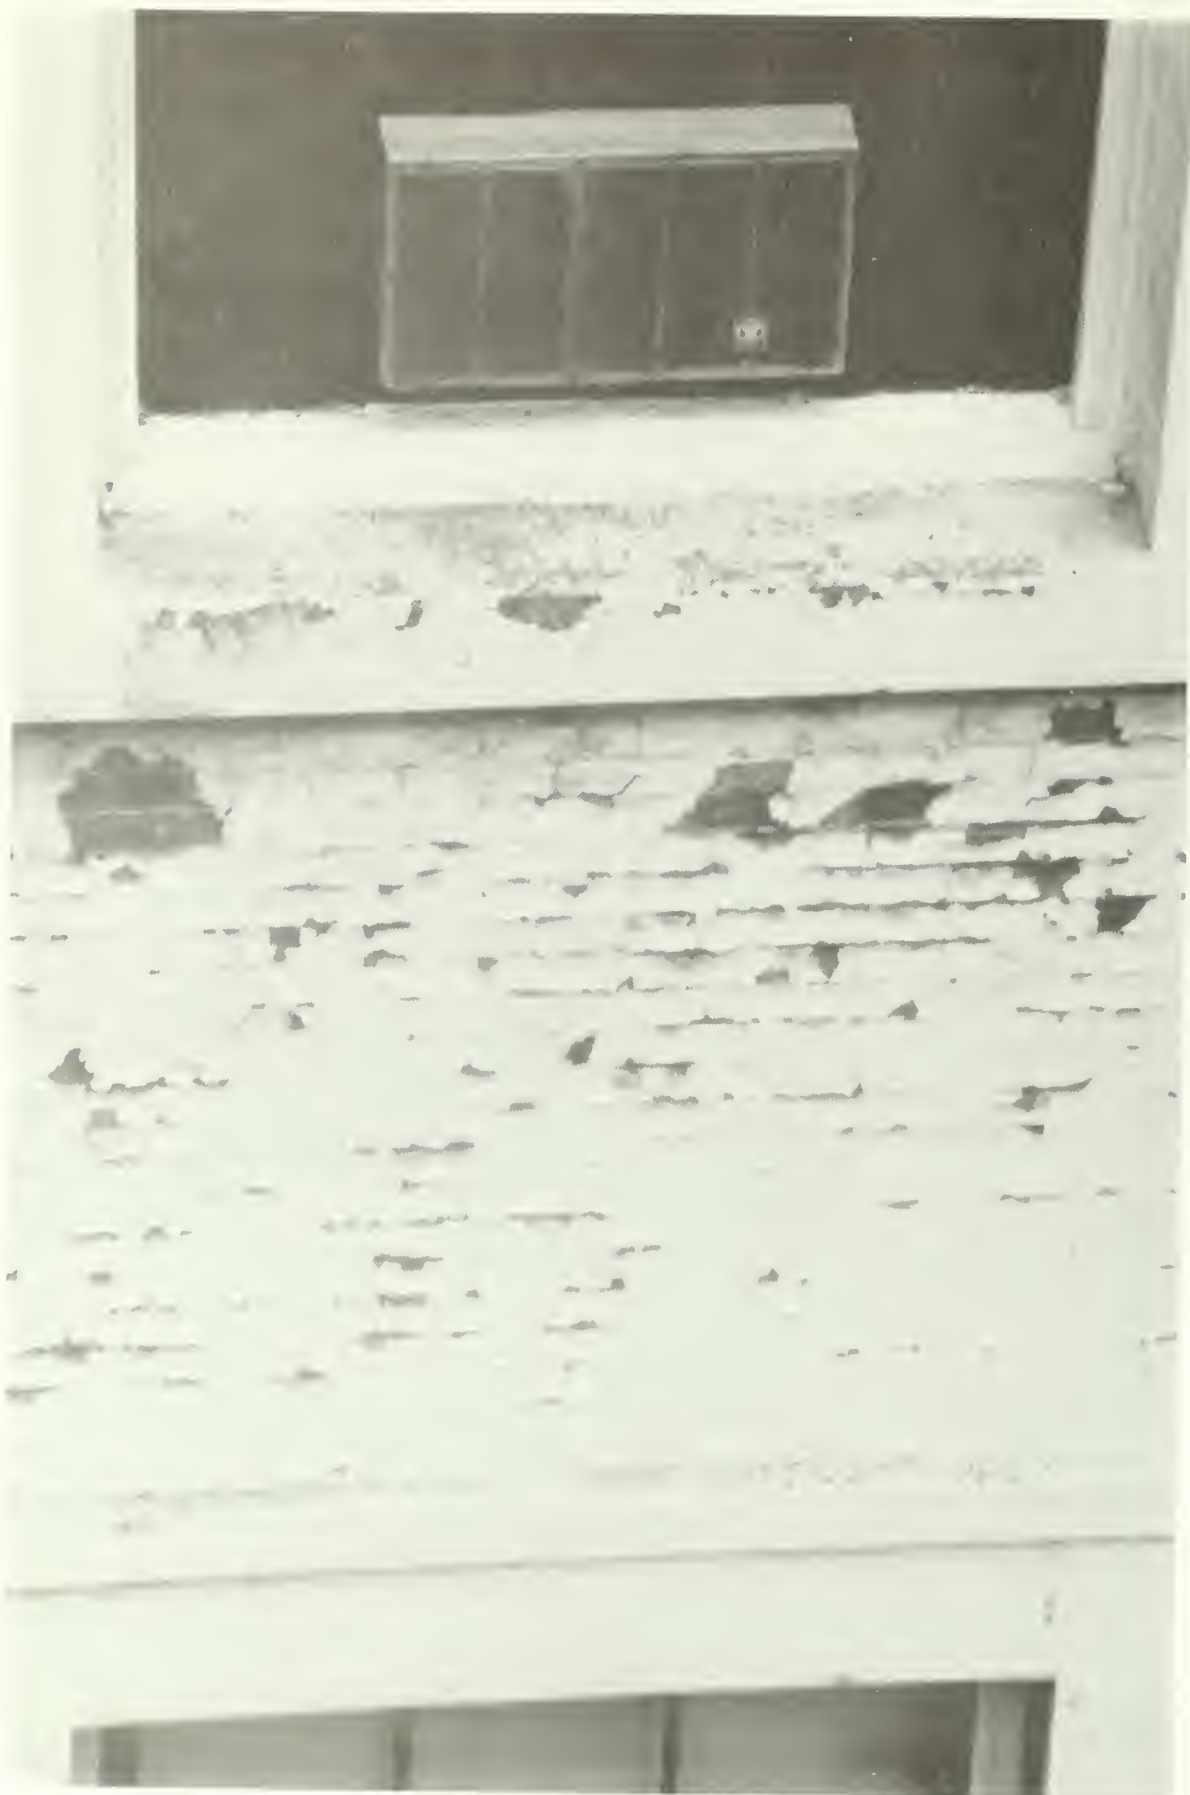
33. Paint deterioration on brick.

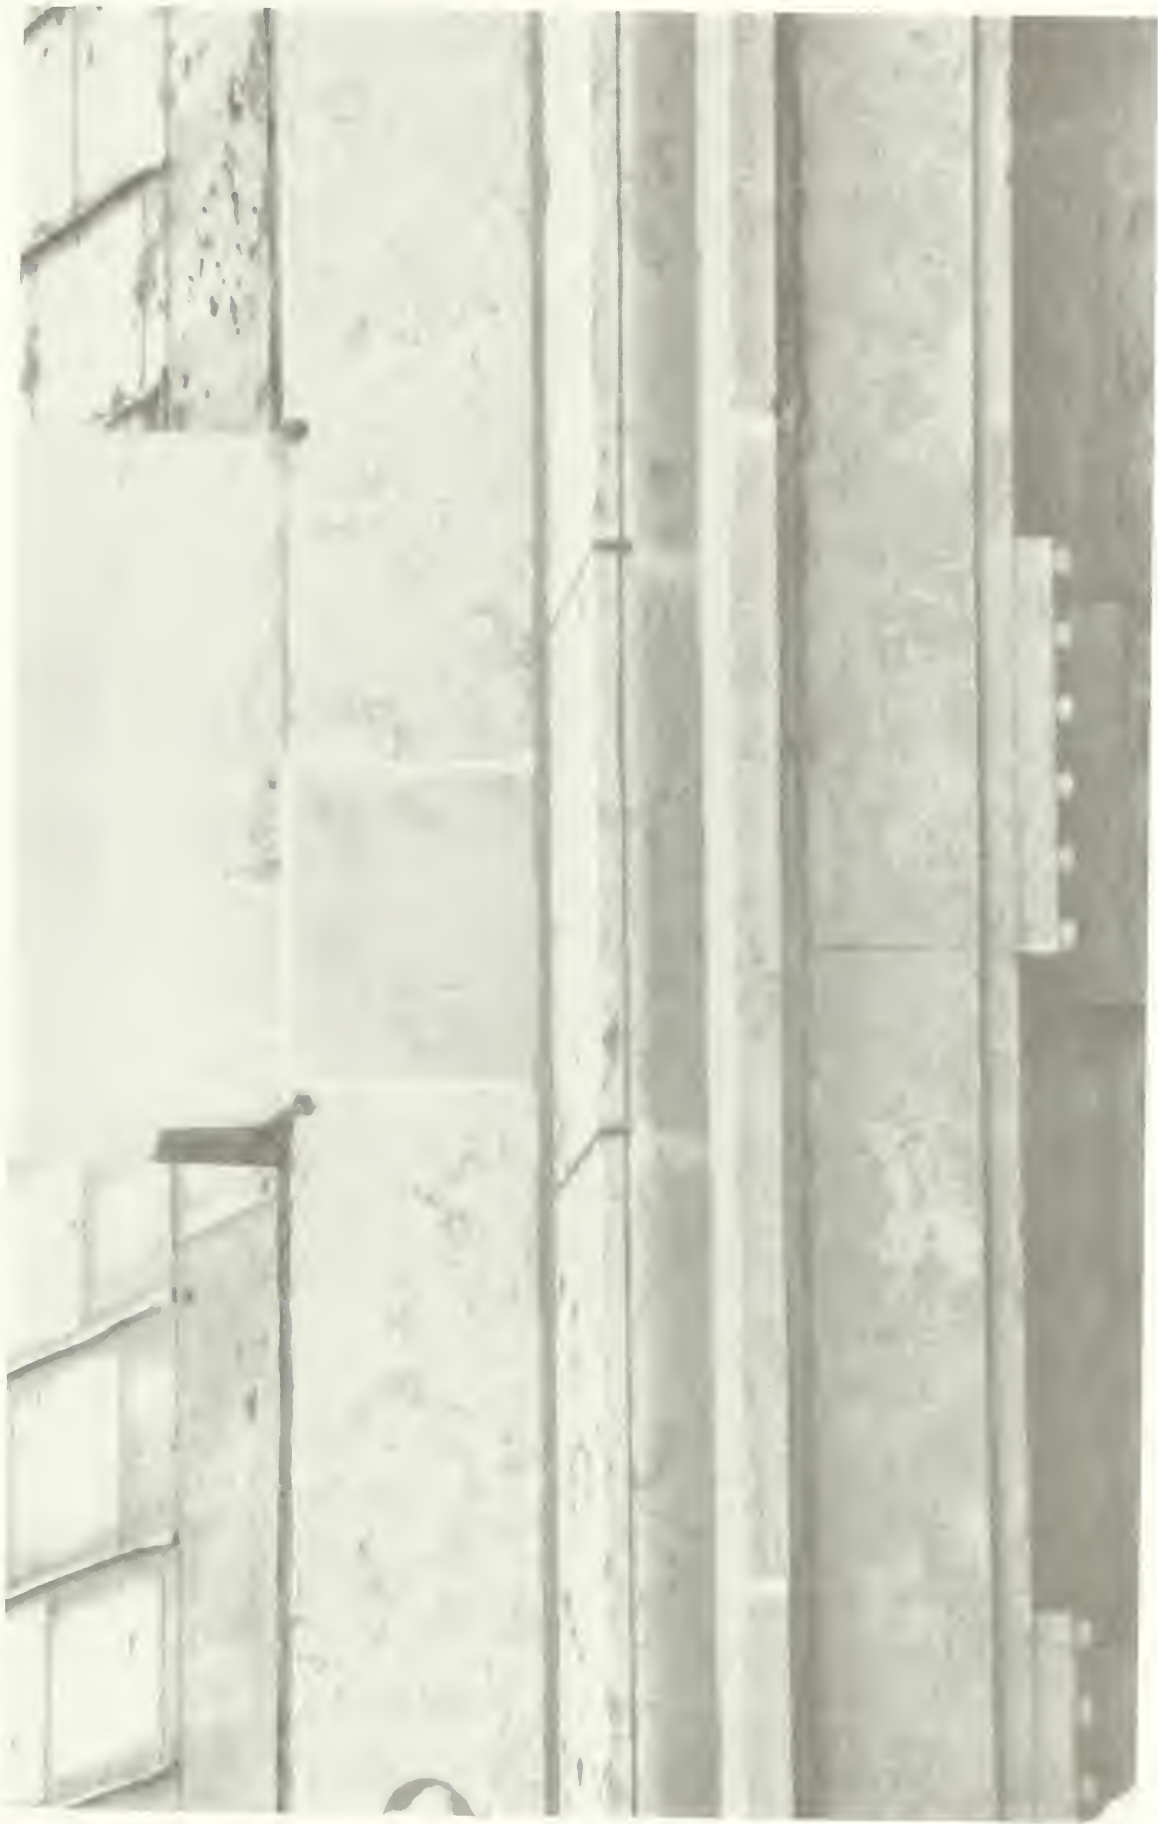
36. Cornice section in relatively good condition. Note replacement stone in parapet.

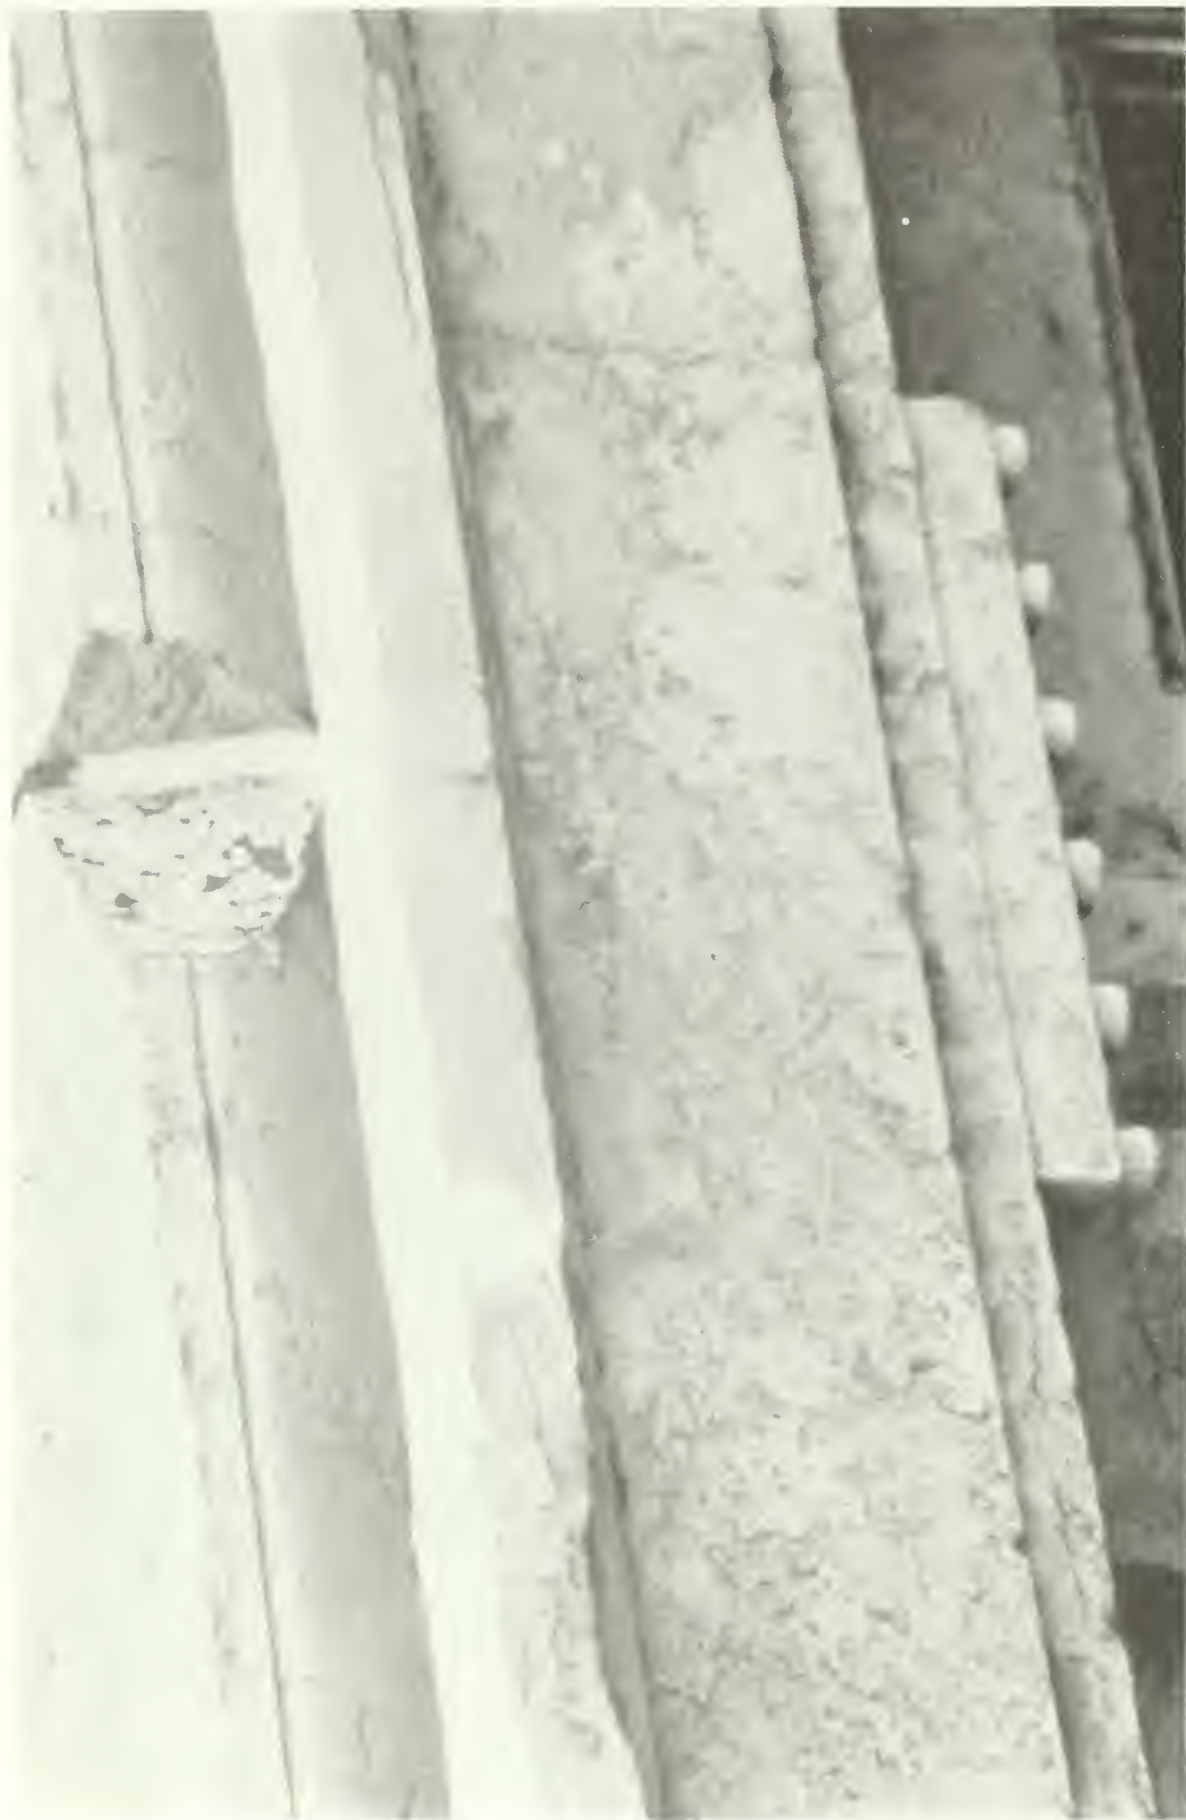
37. Typical chipped section of cornice.

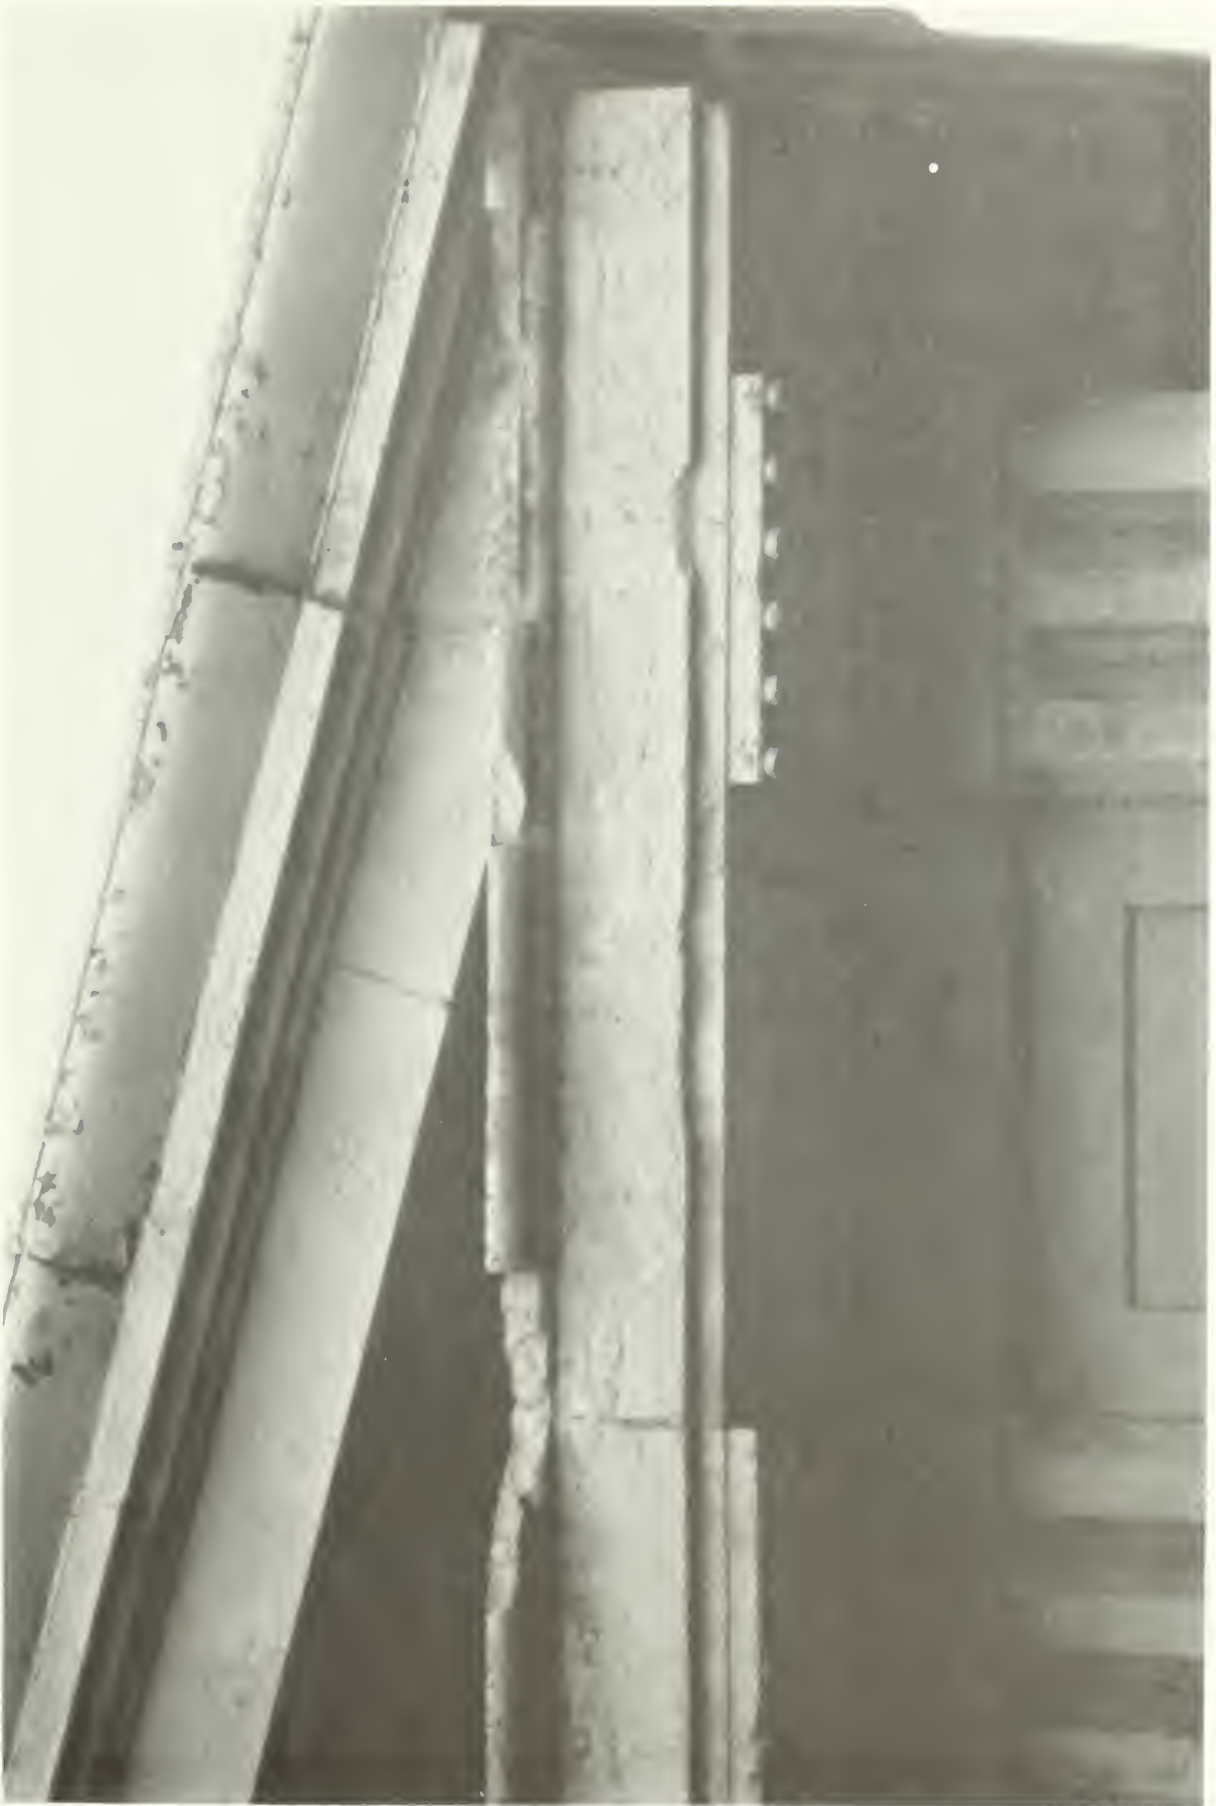
38. Typical cornice spalling.

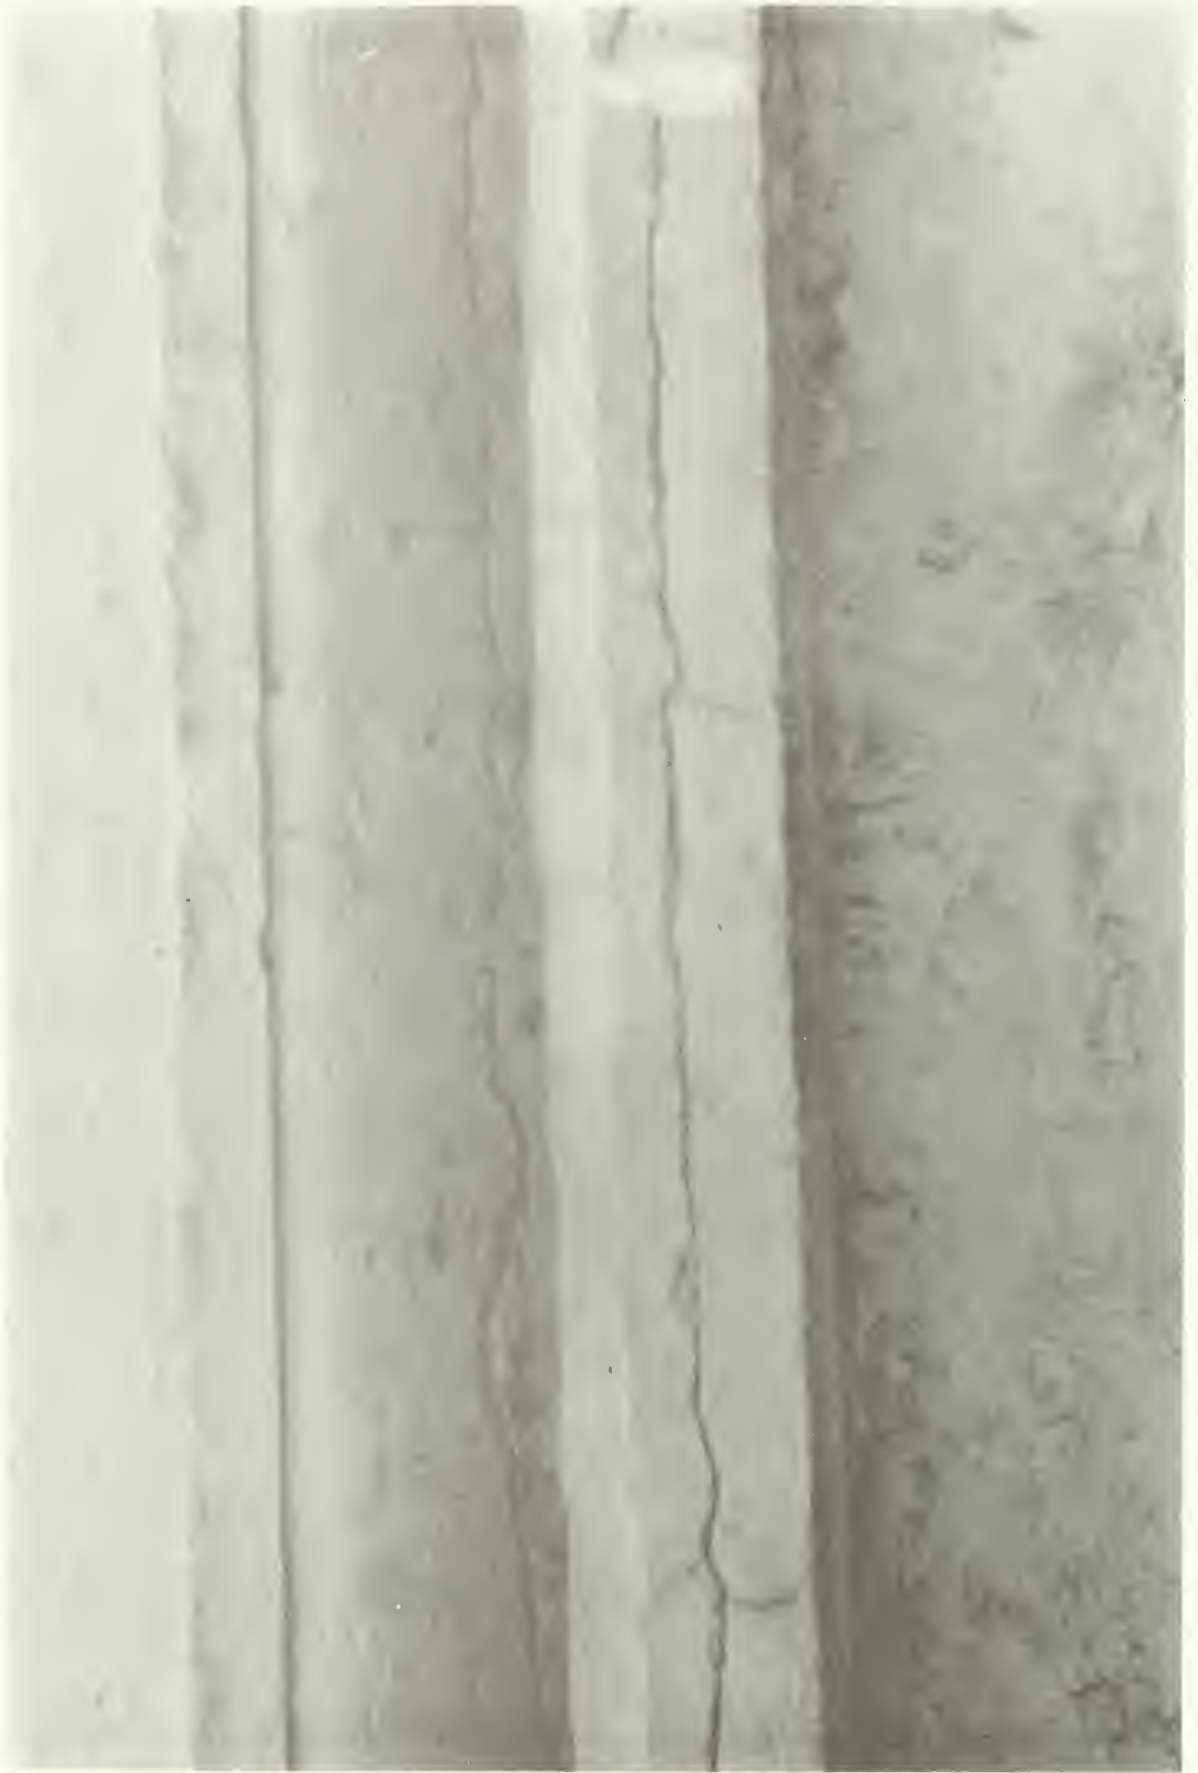
The lowest of the three stone courses comprising the cornice must be carefully inspected to determine the direction and condition of these stylolite joints. When they run parallel to the wall surface, the projecting portion of the stone runs a high risk of separation. This weak joint is treated to the full weight of the cantilevered portion of the stone and the two courses above it. Since the cornice is covered with up to 18 layers of paint, these features are currently difficult to impossible to detect until the surface is cleaned.

39. Typical fissures or stylolites at main cornice.

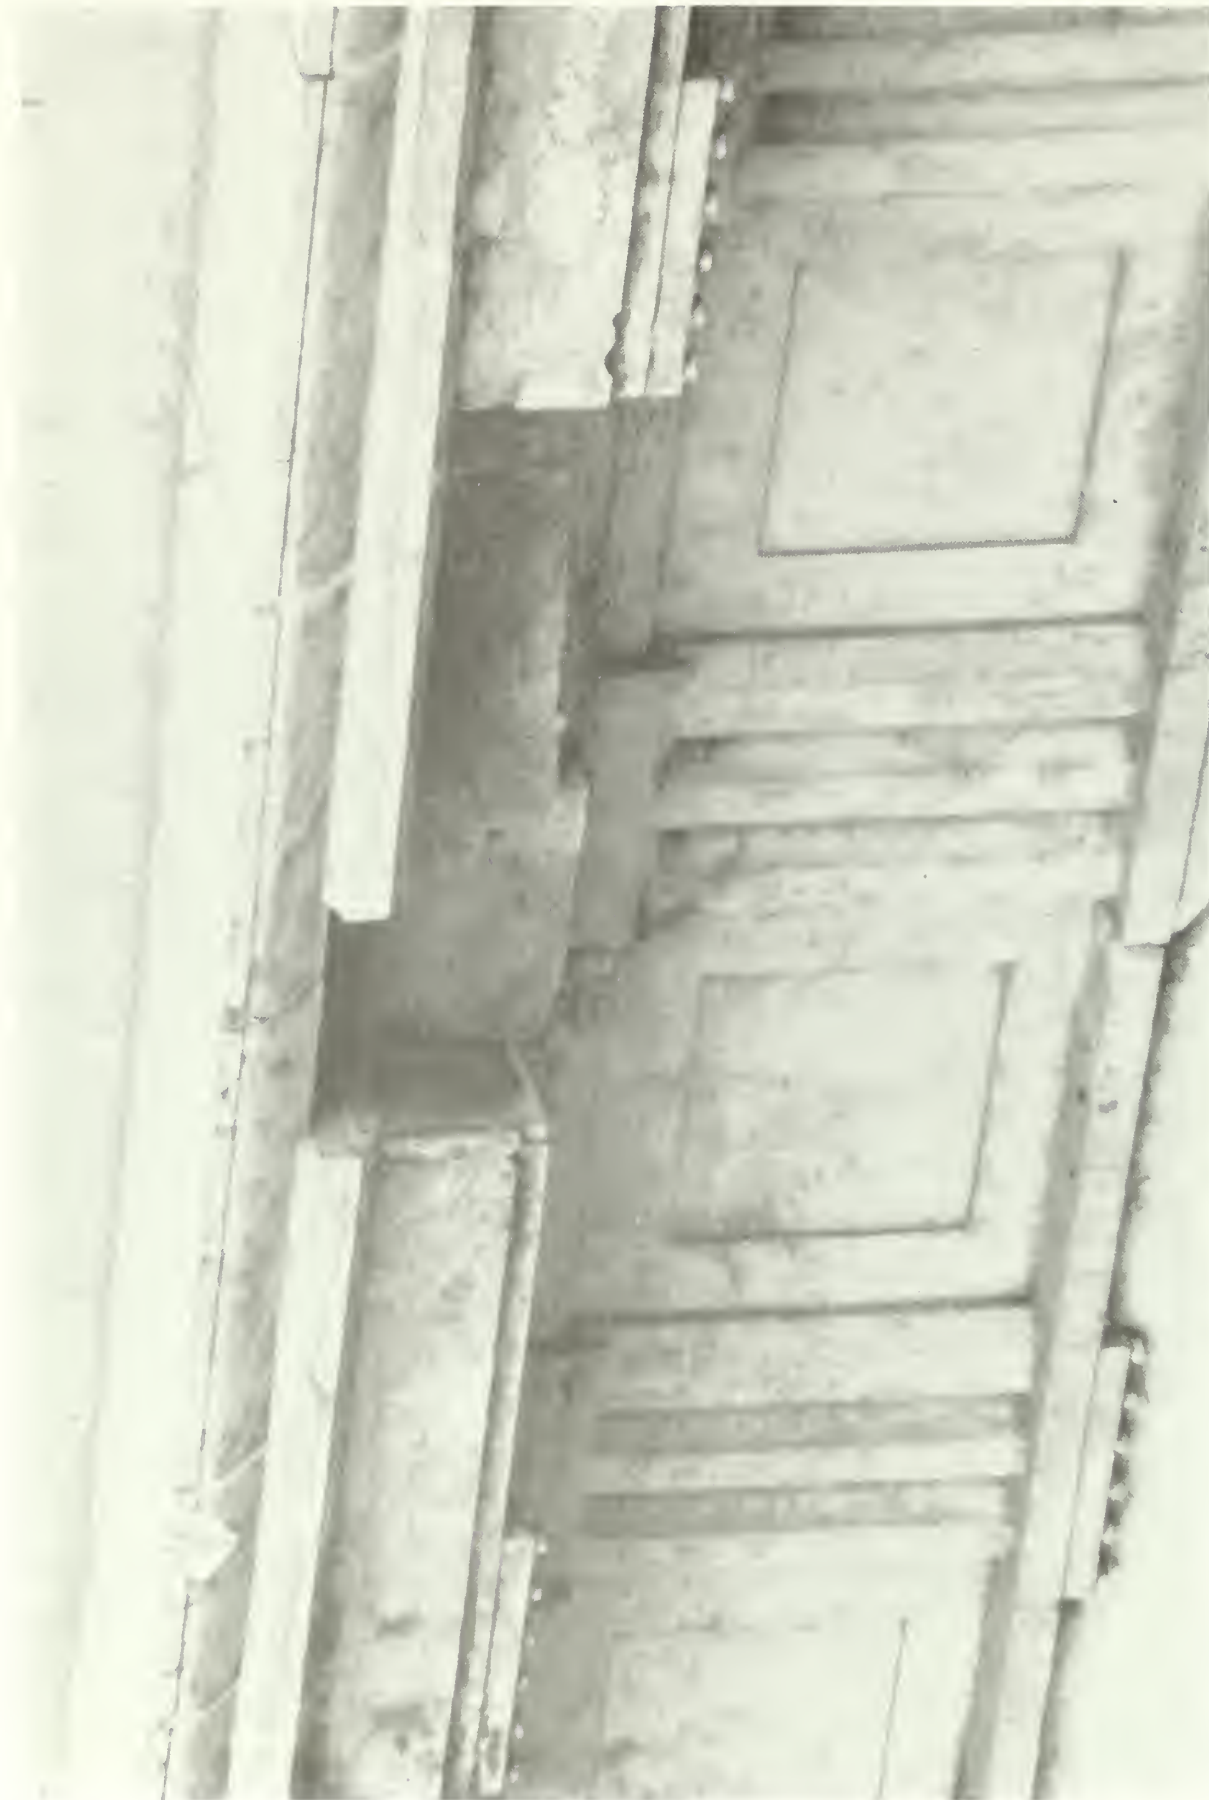
41. Missing section of cornice, north side of east wing near portico.

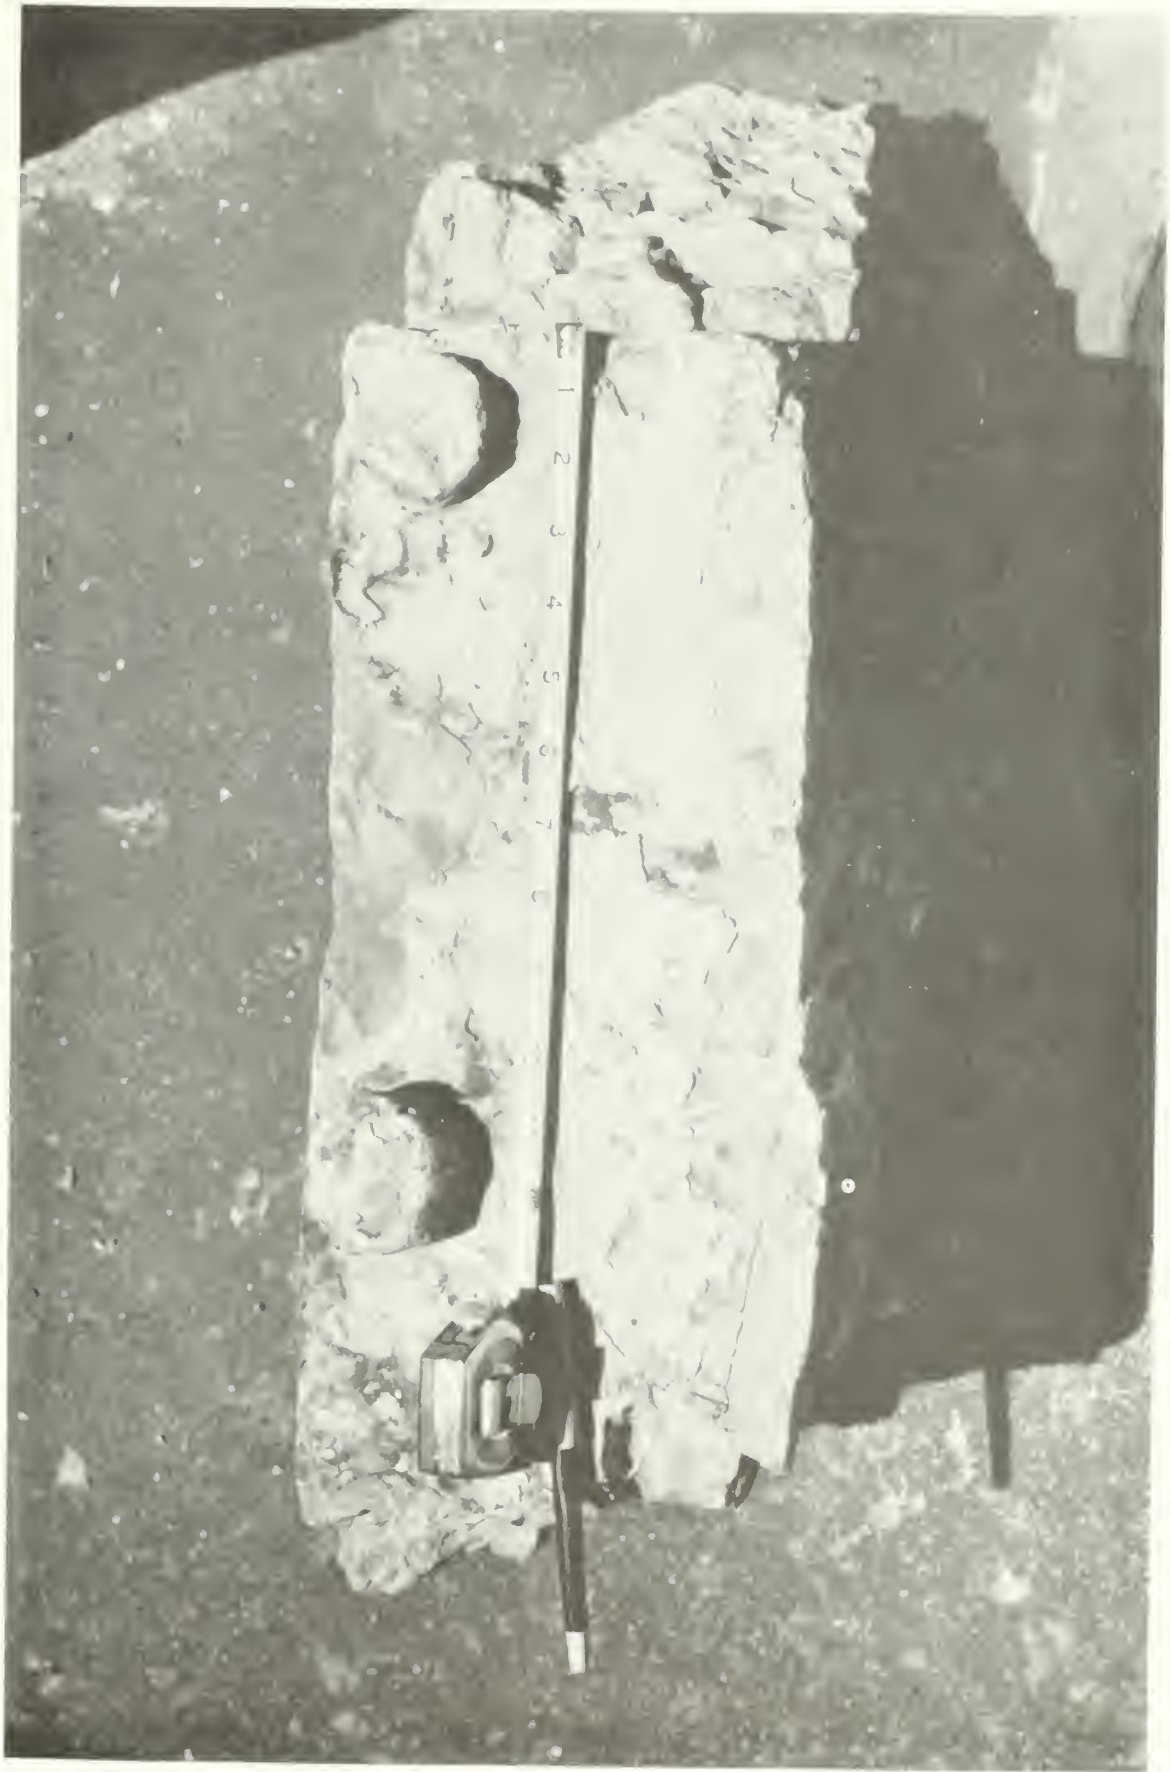
42. Fallen section of cornice from north wall, east wing.

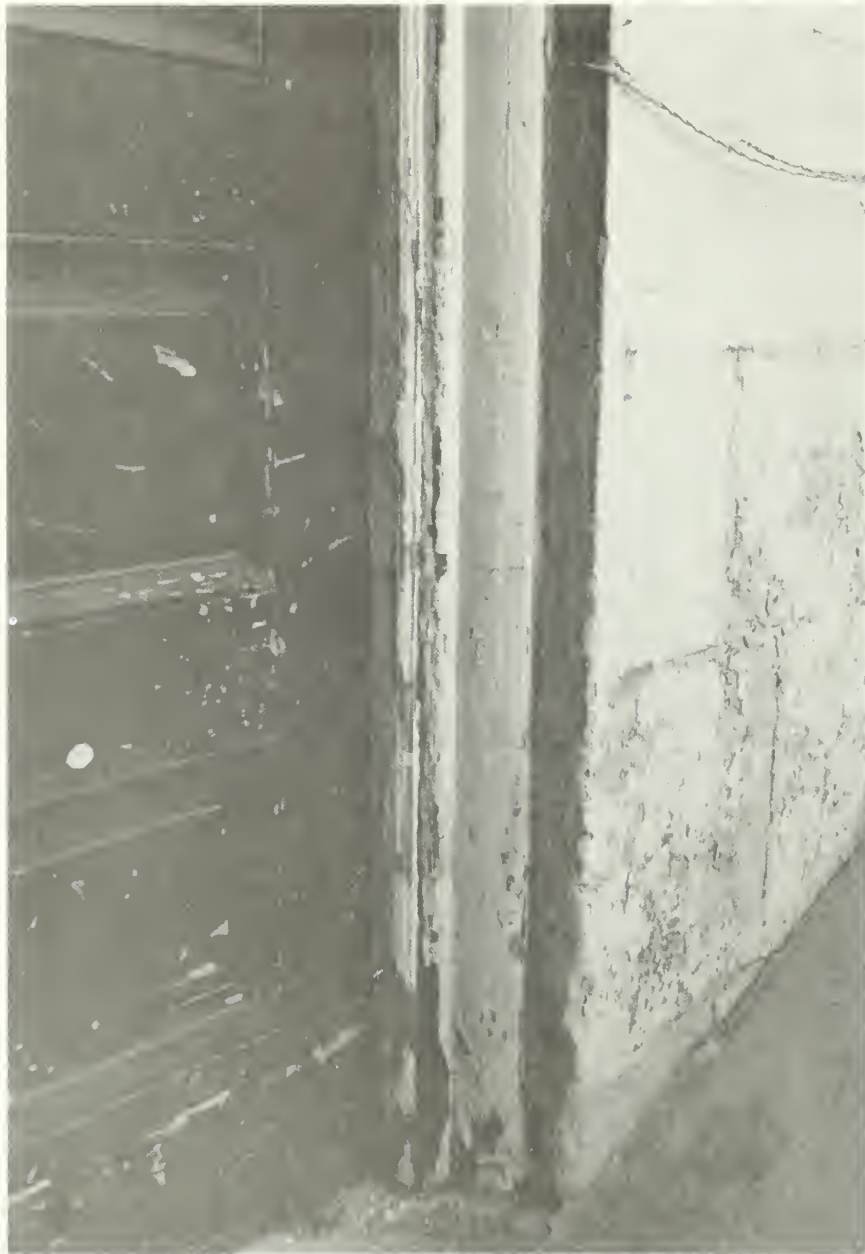
45. Typical deterioration at lower portion of basement doors and jamb.

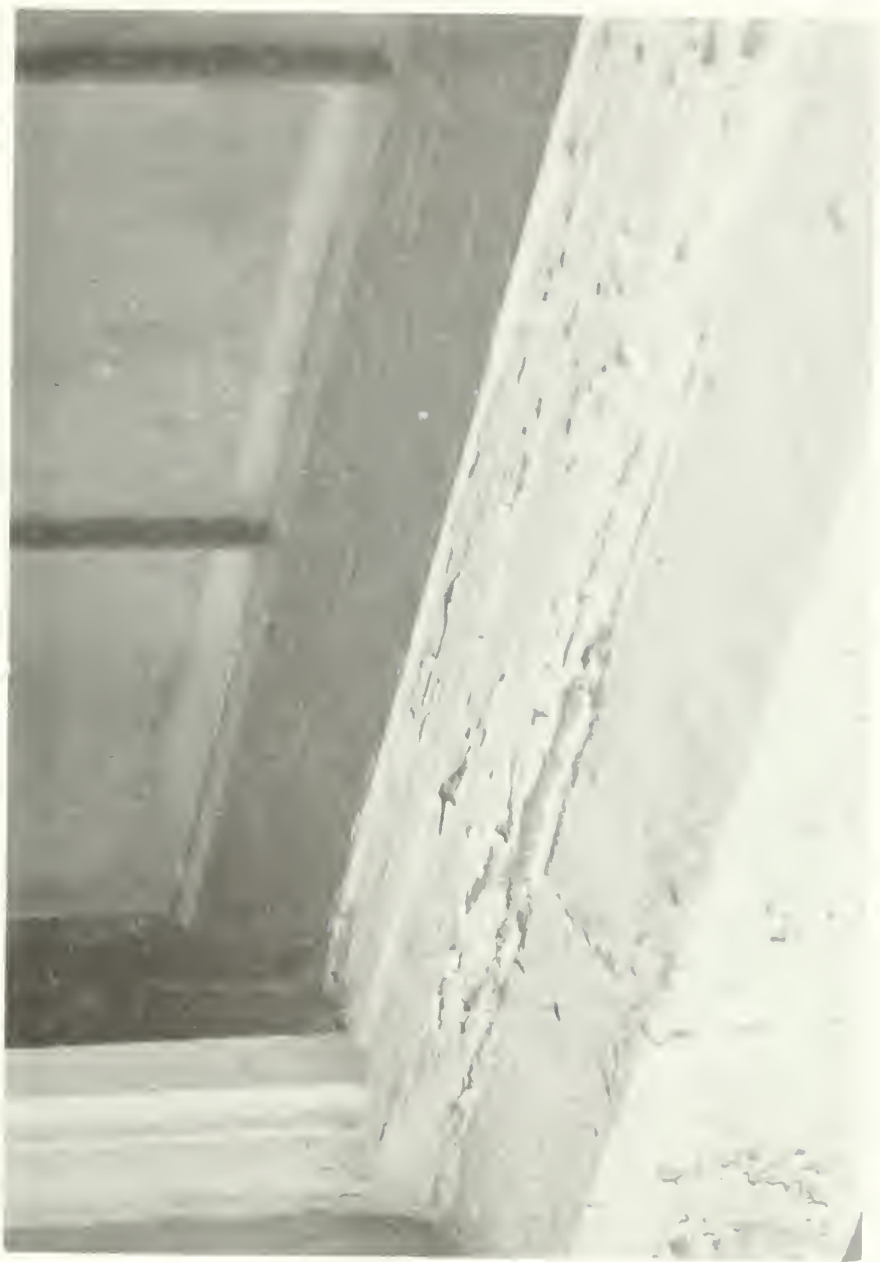
46. Typical window sill deterioration.

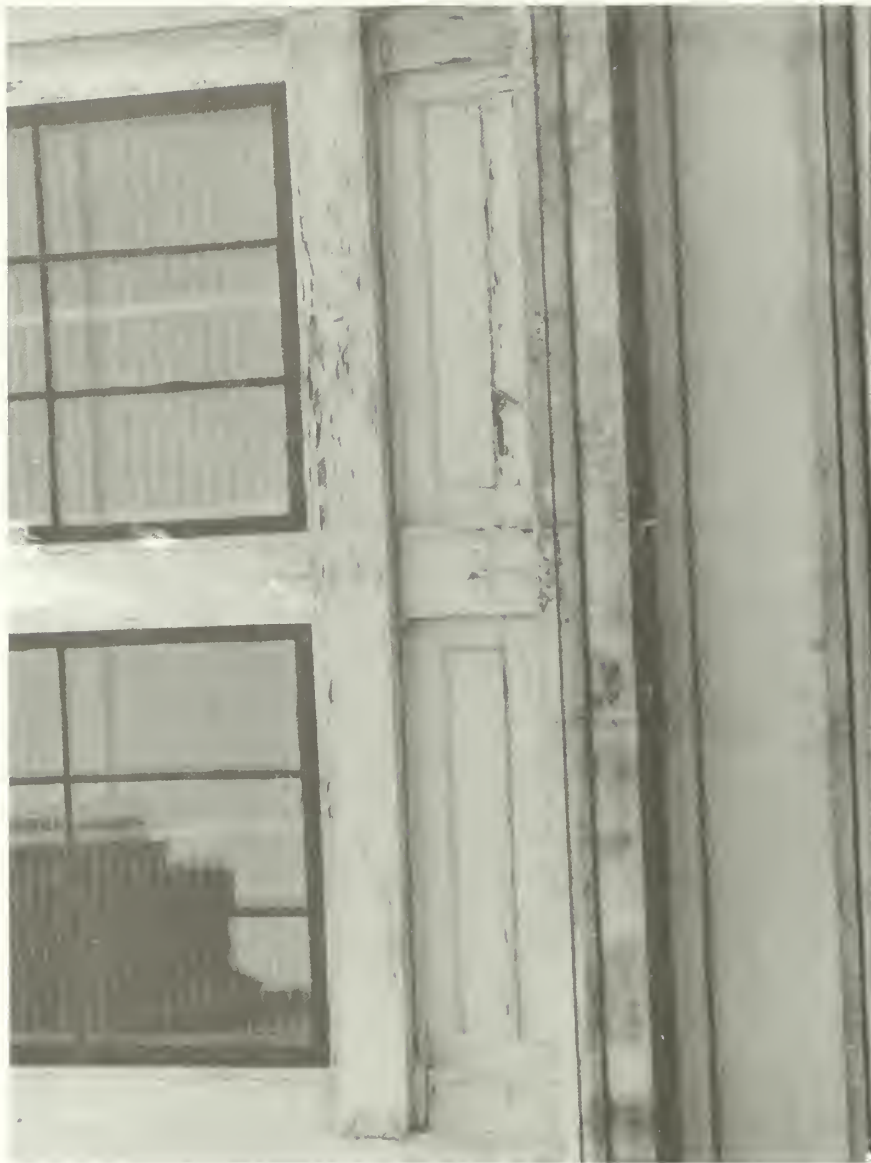
47. Typical deterioration at wooden transverse hall window infill panels.

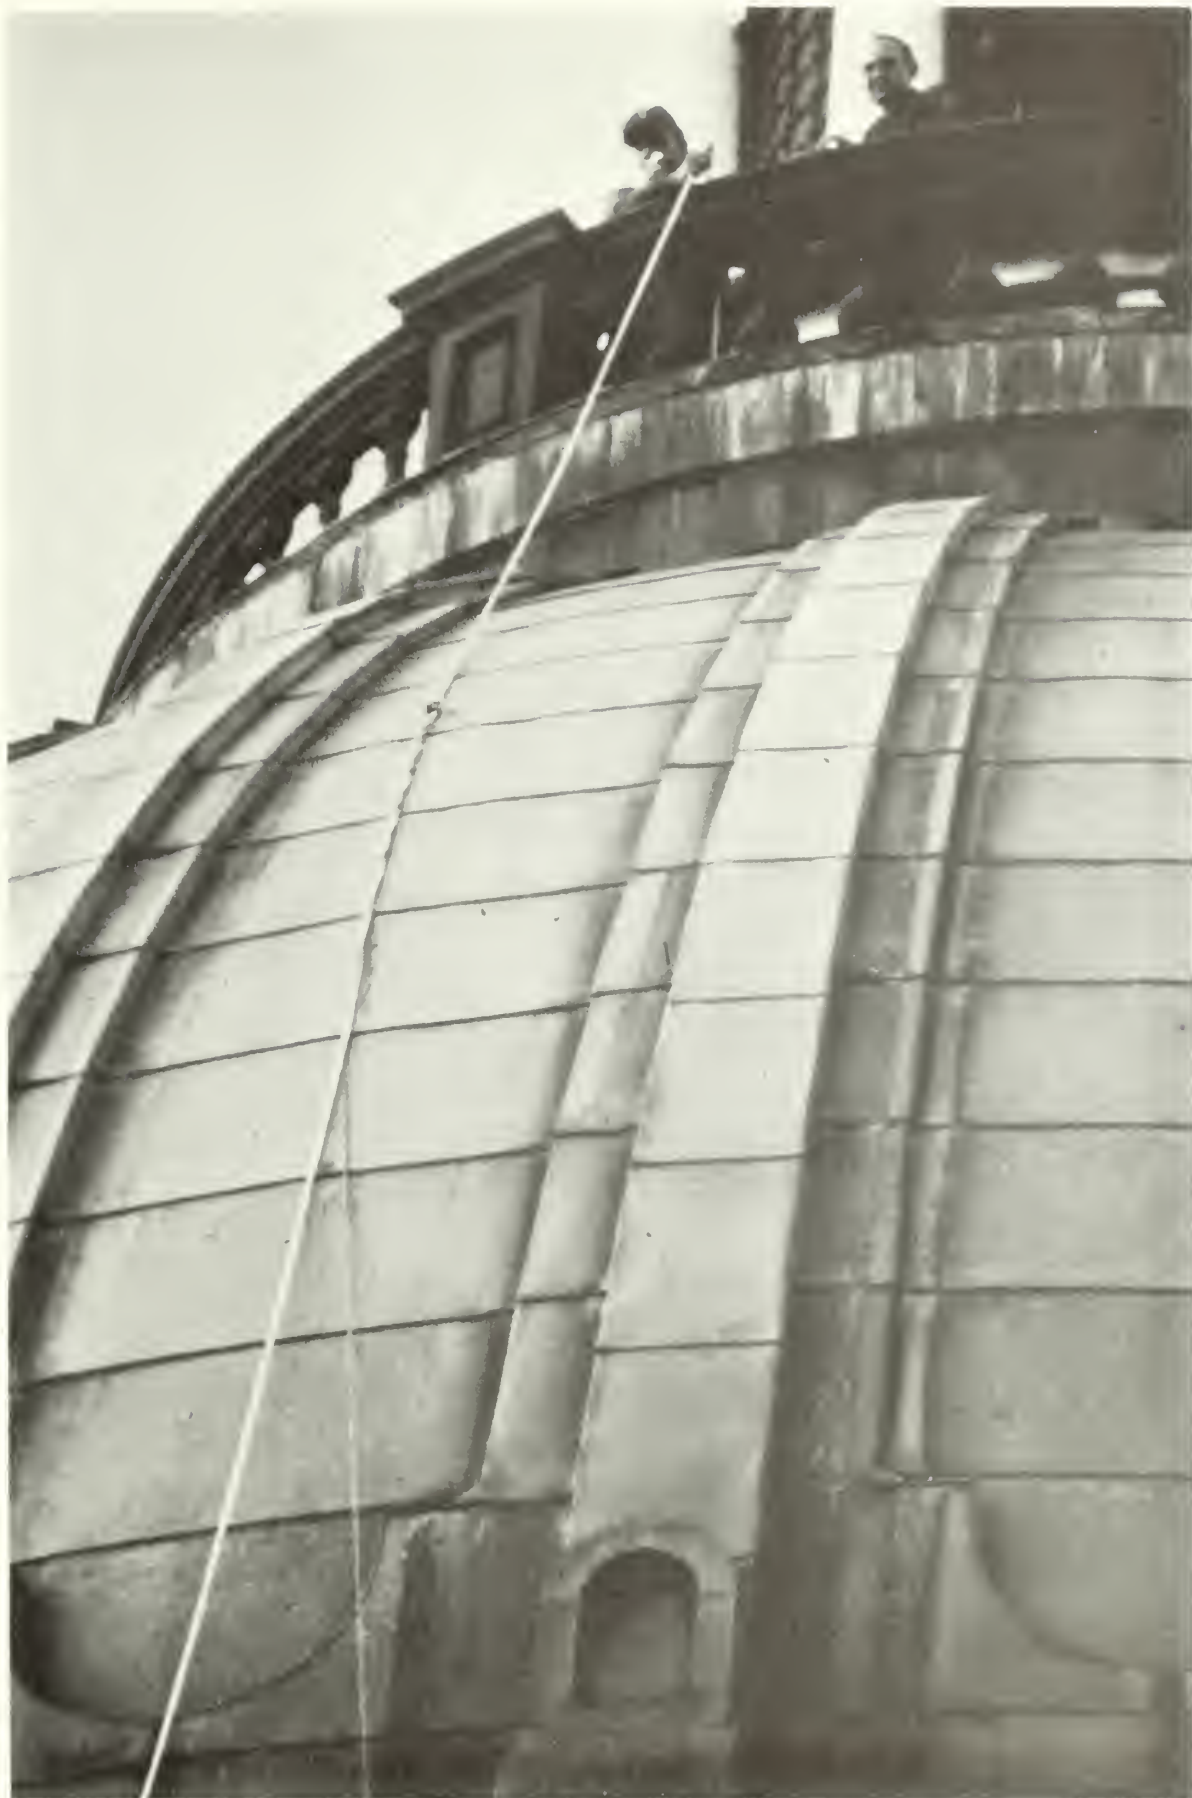
68. Upper dome and lantern. Note staining below balustrade.
